UNITED STATES ATOMIC ENERGY COMMISSION

TID-5214

ELECTRICAL EQUIPMENT FOR TANKS AND MAGNETS

April 1947

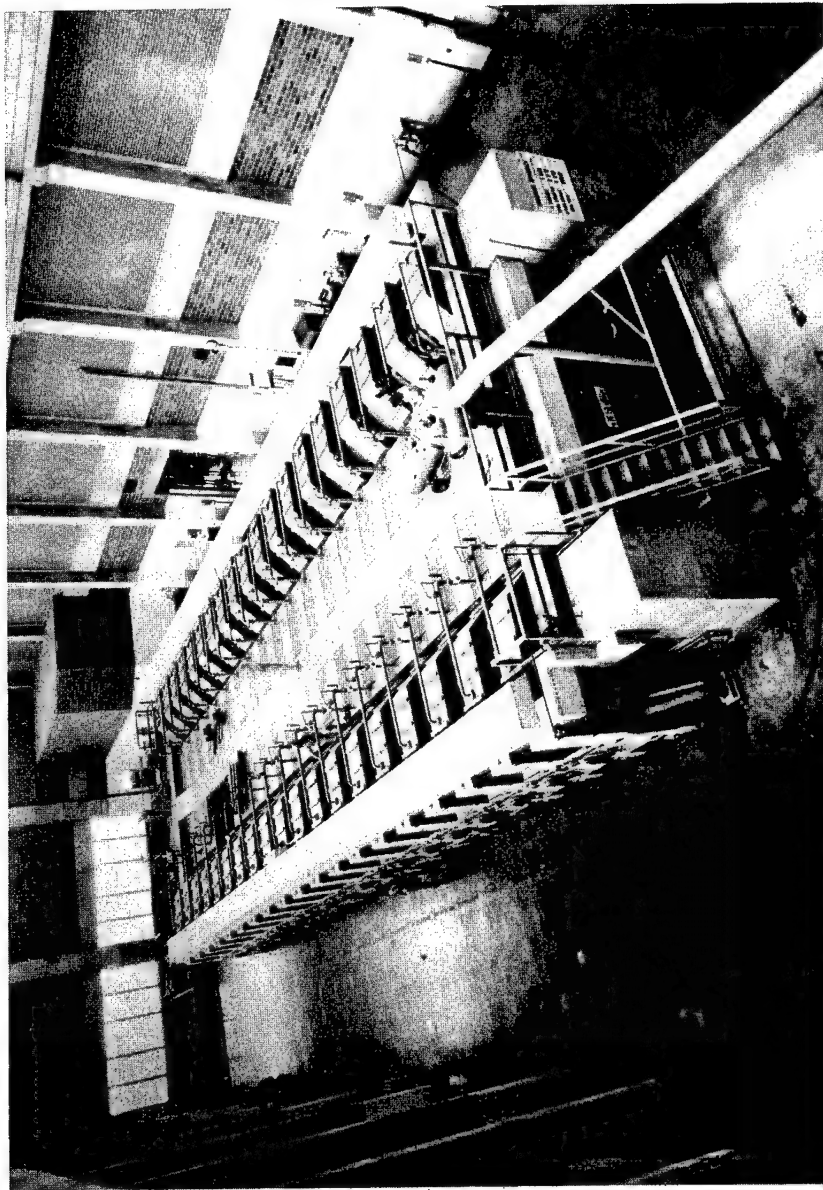
Fig. 18.3 — View of Beta magnet.
